AIA Document G704™ - 2000**Certificate of Substantial Completion****PROJECT:**

(Name and address)
Oak Creek Village Apartments
2324 Wilson Street
Austin, Texas 78704

CONTRACT FOR: General Construction
CONTRACT DATE: May 21st, 2014

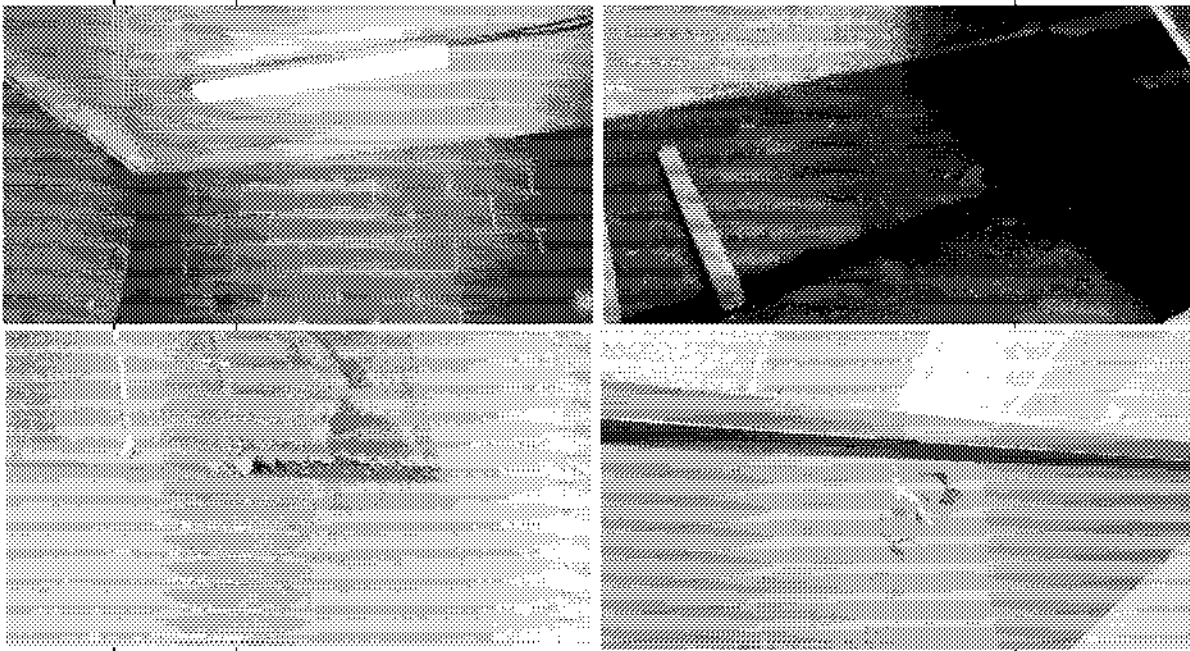
Location	ID	Description	Photo
Stair 1 North	#10	Interior stairwell walls were not adequately protected during ceiling painting, railing painting, and other operations and require cleaning. 1" of standing water observed at the bottom level of the stair, source unknown. Code-required signage still missing from Level 3 egress gate. Level G1 door, fire rated, stops short of fully latching. Level G1 wall has exposed OSB left over from forming that needs to be removed & joint sealed.

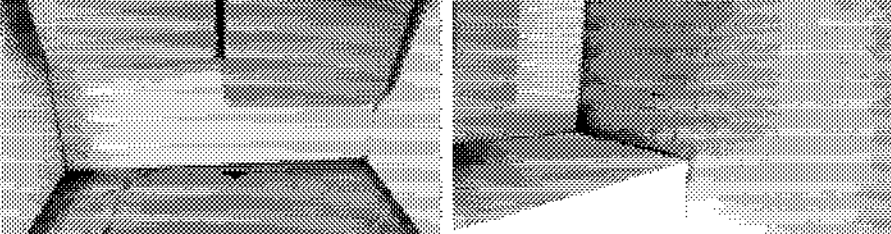
Water Fountains: repair base of wall trim, remove loose material protruding from beneath base trim, provide seamless patch at cut concrete slab

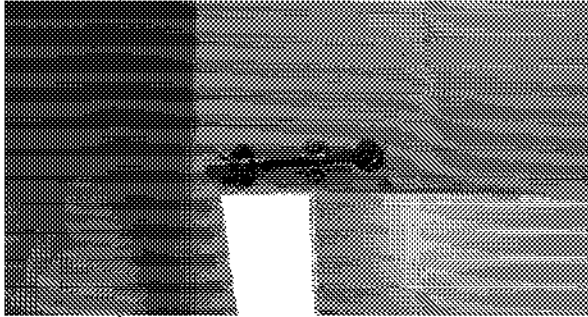
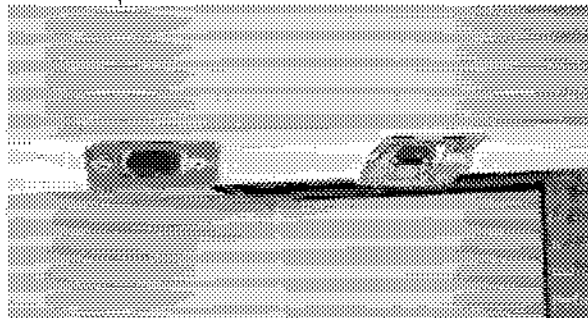
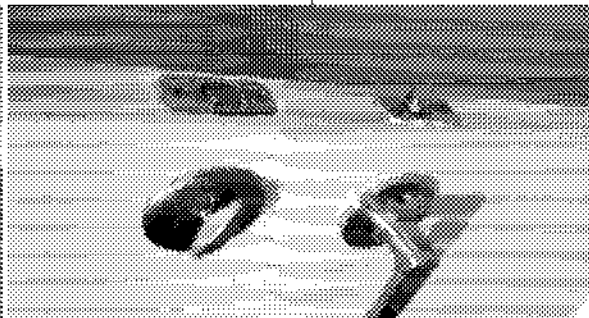
Business Center Cont.

<p>Door Hardware: Replace damaged closet door hardware, and re-install the rest with proper prep. Strike plates and latch plates are not mortised in. Flush bolt is crooked. Random screws used. Paint on hinges. Paint on latch rosette.</p> <p>@ Barn doors, replace mounting bolt & nut with flat head, flush fastener.</p>
Theater / Classroom	<ul style="list-style-type: none"> - Same paint comments regarding wall plates. - Clean recessed lighting trim - remove all fingerprints and paint - Same comments regarding closet door hardware, which doesn't latch. Not one piece of hardware is well installed. - Remove dust coating HVAC equipment and closet. Walls appear to be painted in different sheens

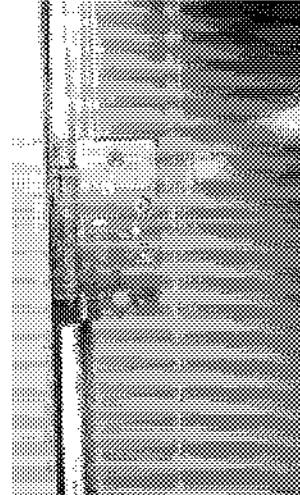
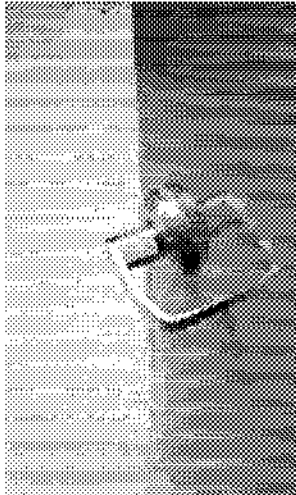
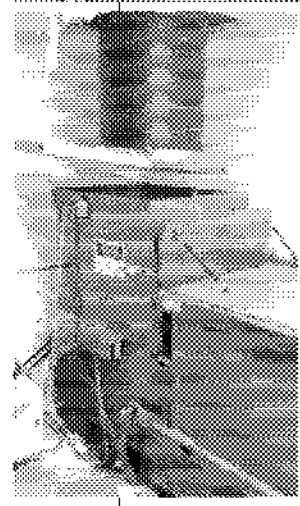
<p>Replace scarred interior door handle. Door handle scratches interior side of door when operated - touch up door paint. Install matching hinge screws in all hinge screw holes. Replace all sheetrock in west half of room. Remediate molded areas. Install FRP as discussed. Confirm that walls are clad in exterior MR Gyp, per 3/A0.03.</p>

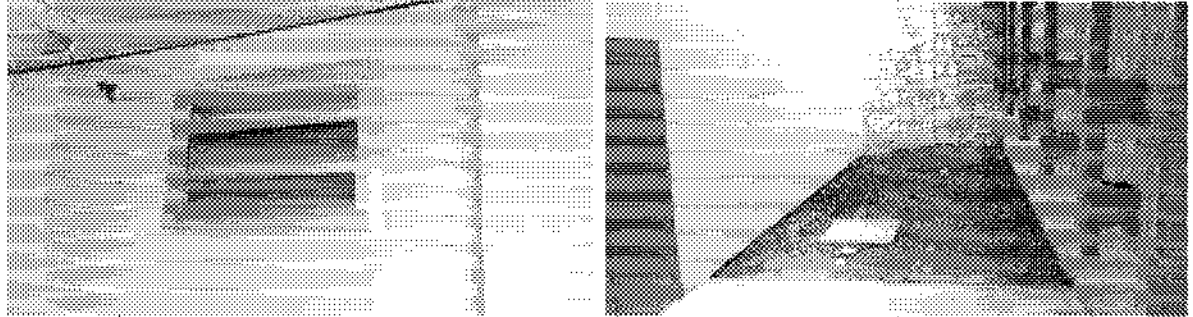
East Trash Continued

<p>PCO 67 called for fire/smoke dampers at the trash room. RFI 118 response called for a 72" picket fence across the edge of sidewalk between Trash & Garage, to block access to the Wilson street yard.</p>
IDF, Building 4, Level 5, South

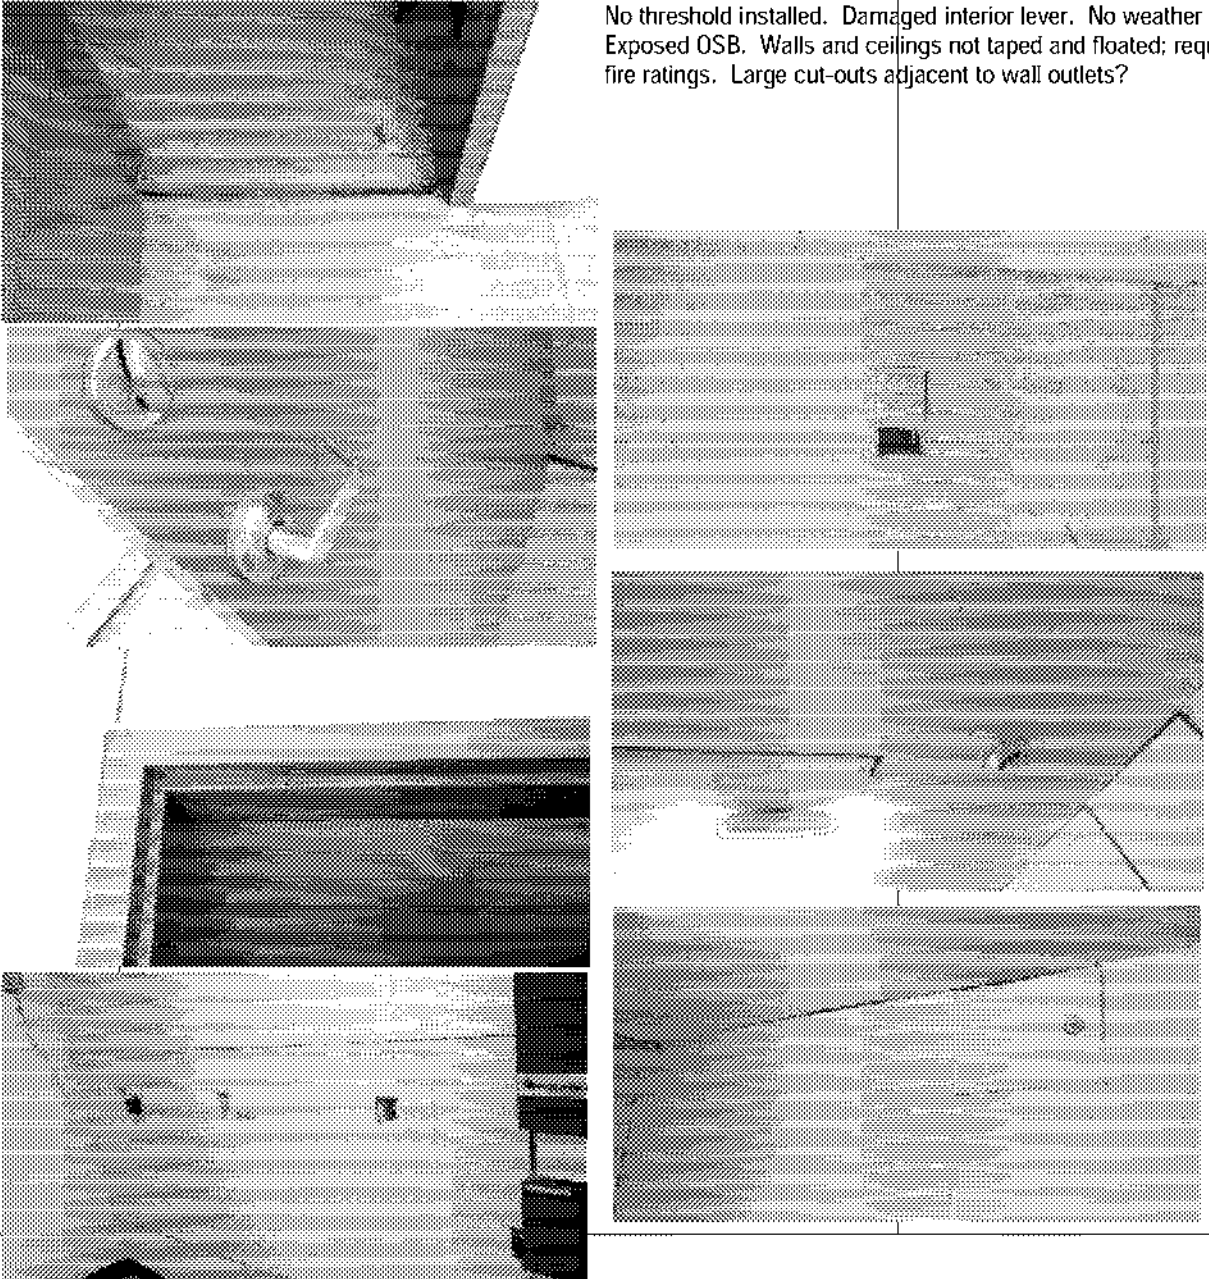
<p>No threshold installed. Damaged interior lever. No weather seals. Exposed OSB. Walls and ceilings not taped and floated; required based on fire ratings. Large cut-outs adjacent to wall outlets?</p>

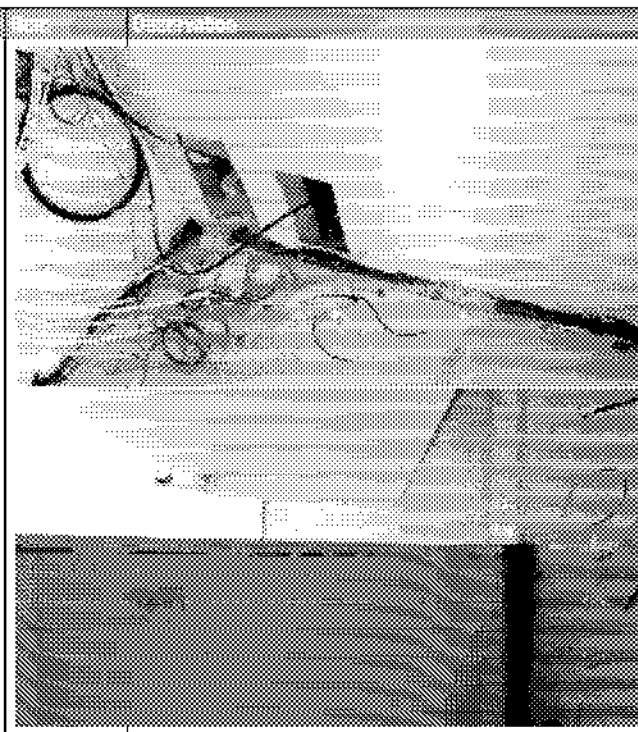
<p>IDF, Building 4, Level 4, North</p>

<p>Similar comments to IDF level 5. Room is not finished. Open holes into unit demising wall are unacceptable for fire rating. Door lacks deadbolt and cannot be secured. This is a wood-framed wood interior door in an exposed exterior location and should be HM.</p>
<p>Comm. Room, Bldg 3, Lvl 3</p>

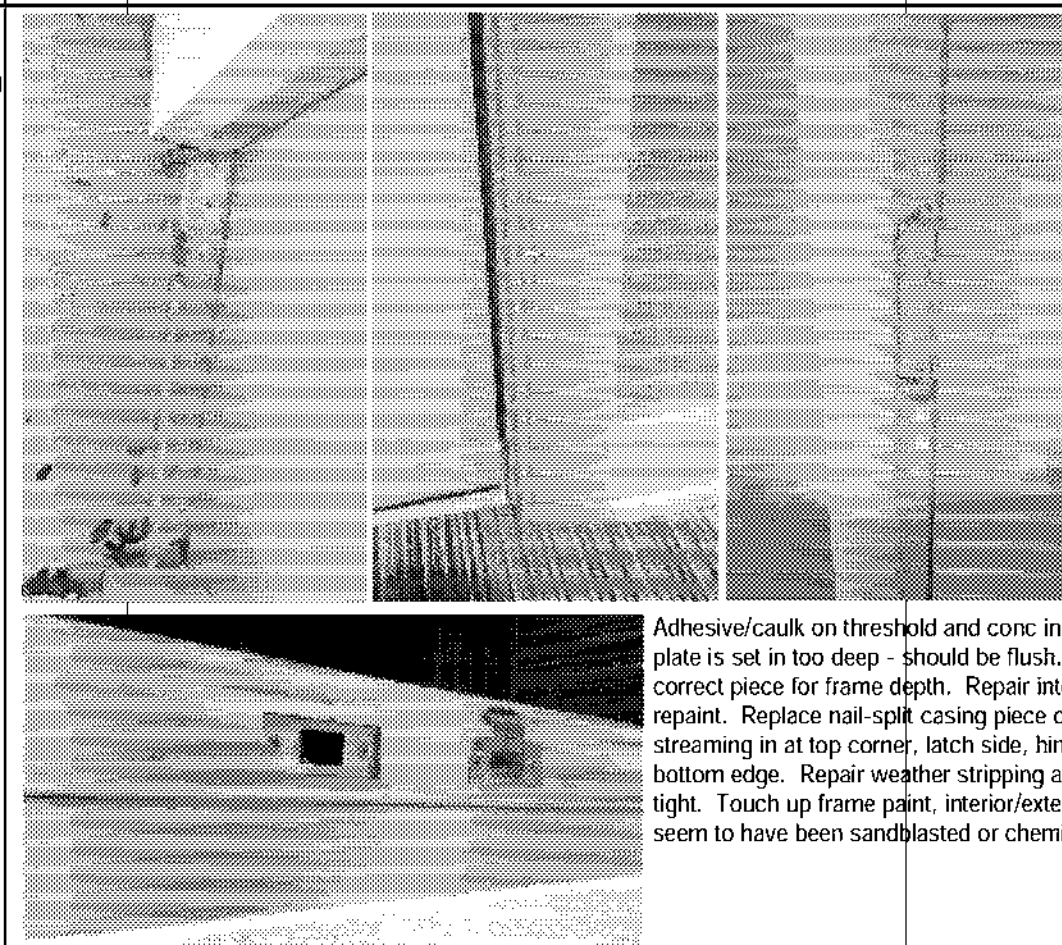
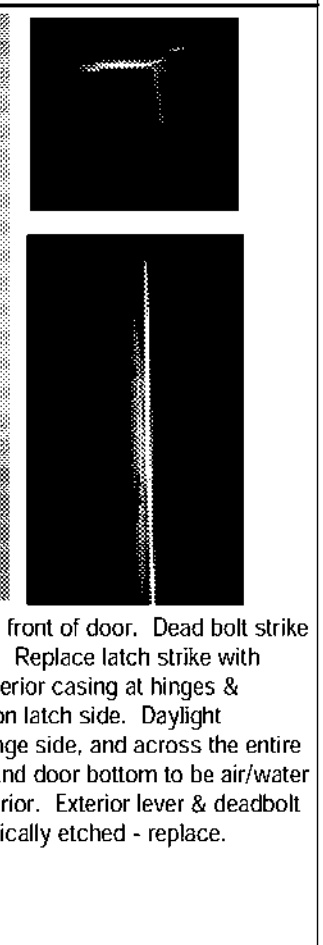
<p>Adhesive/caulk on threshold and conc in front of door. Dead bolt strike plate is set in too deep - should be flush. Replace latch strike with correct piece for frame depth. Repair interior casing at hinges & repaint. Replace nail-split casing piece on latch side. Daylight streaming in at top corner, latch side, hinge side, and across the entire bottom edge. Repair weather stripping and door bottom to be air/water tight. Touch up frame paint, interior/exterior. Exterior lever & deadbolt seem to have been sandblasted or chemically etched - replace.</p>

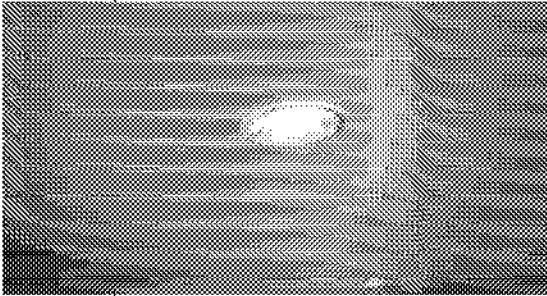
Location	Room	Issues/Notes	Photos
Comm Room		Clean and tighten light trims.

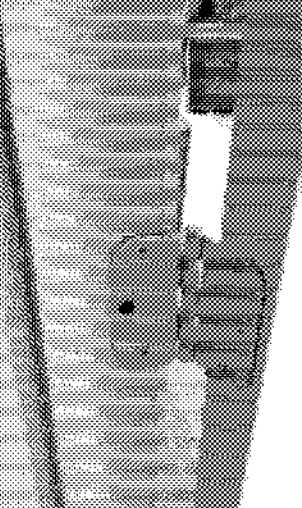
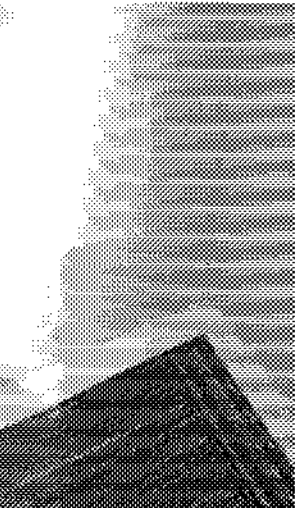
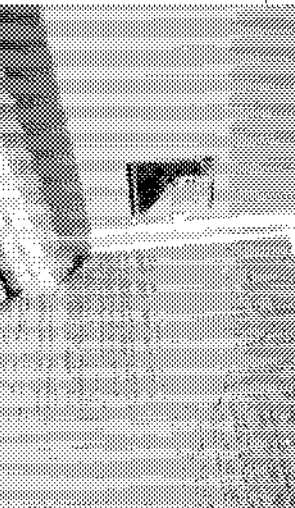
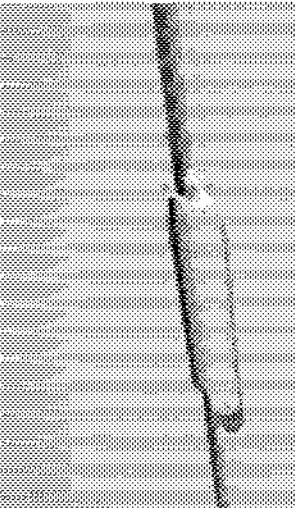
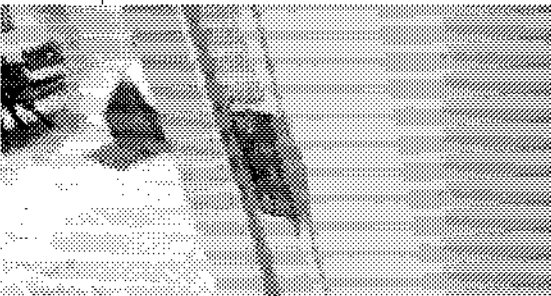
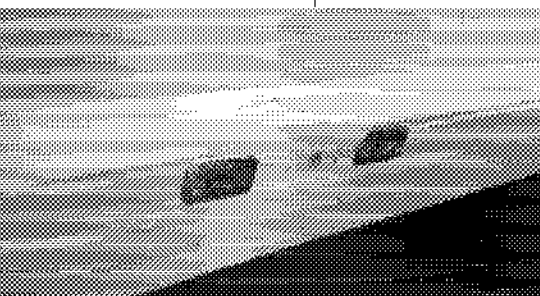
Comm Room

Remove paint from all door hardware (typ all doors). Replace frame & casing pieces with bad cuts for hardware prep. Use hinge screws in hinges. Provide cover plate for open pull box.	
Fitness

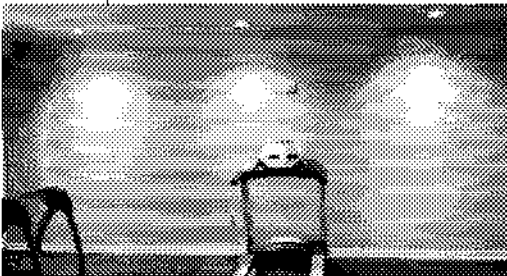
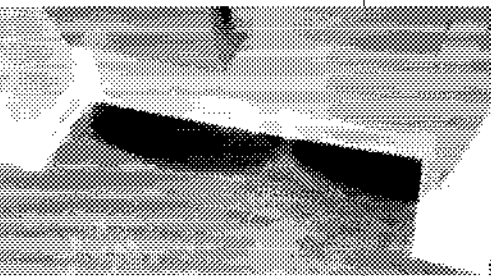
At one point, a large mirror was discussed for the north wall - was this not approved? Paint on rubber floor tile below water fountain

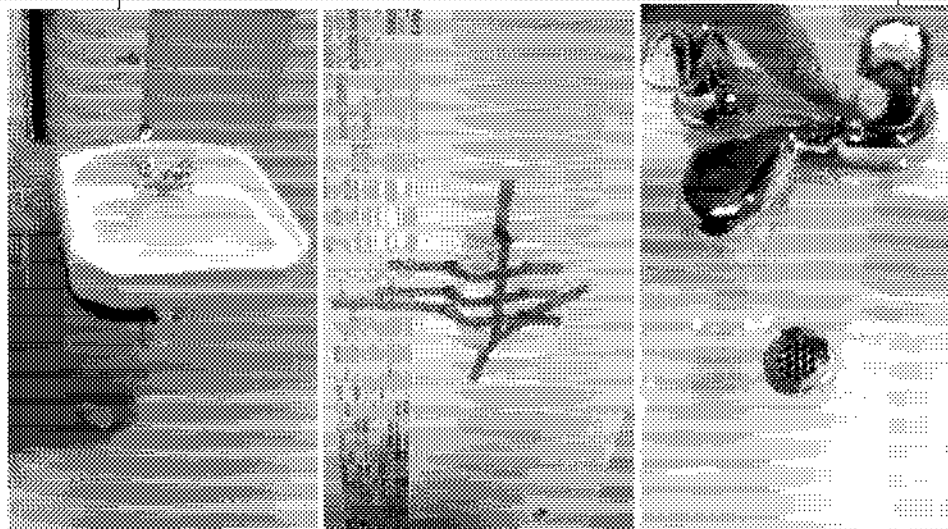
Fitness RR, South

<p>No water @ sink. Emergency lighting not fully mounted. Excess grout on floor.</p>

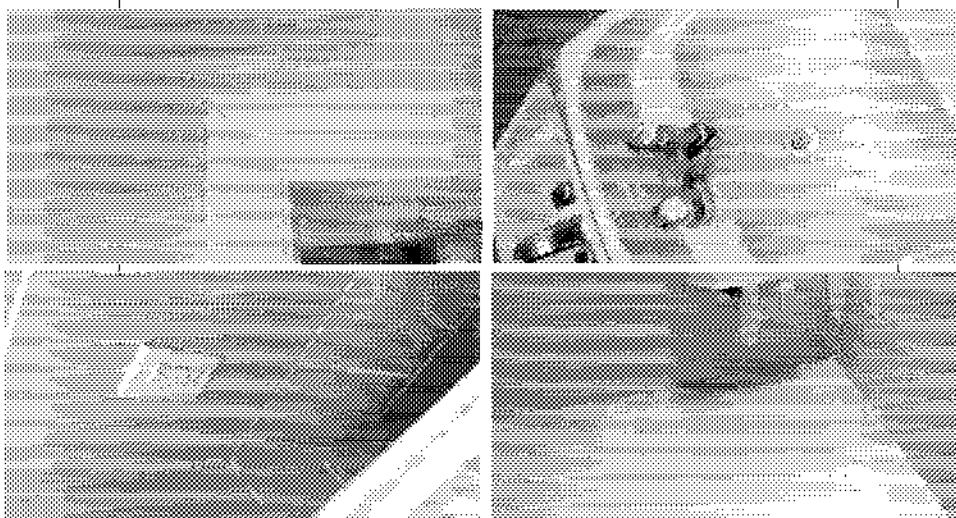
Fitness RR, North

<p>Sand & repaint top left corner of door casing. Remove excess grout from walls & floor. Clean floor. Sink does not produce hot water.</p>
Fitness

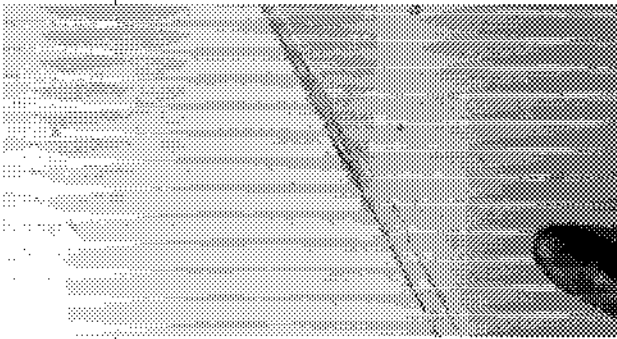
Breezeway, Bldg 3, west of main entry

Large gap between pavers & topping slab was sealed, not filled with a cedar or redwood strip as discussed. As a result, removing the paver for maintenance or replacement will ruin the joint. Sealant was applied very poorly & unevenly, backer rod is protruding from the middle of the joint.
6th floor deck

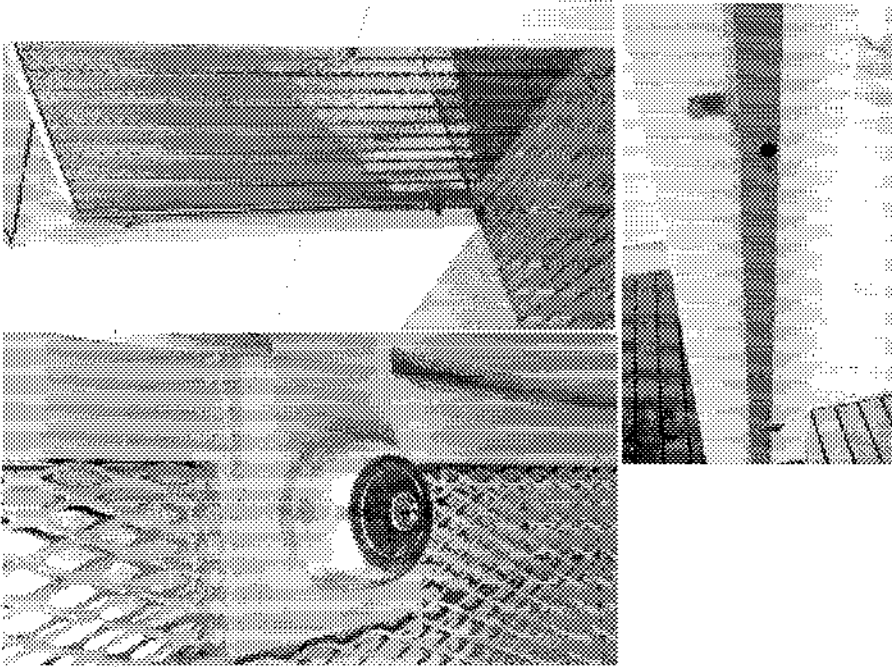
South deck access gate was not installed per design. PCO-61 has this gate mounted on the north face of this opening, not inside of it, so that it can open 180 degrees and lay flat against the breezeway wall. As installed, the door opens 90 and obstructs egress in the breezeway corridor. Would accept flipping the swing to open inward and lay flat against the Kitchen wall. Re-install, and provide hold opens for both gates as indicated in the PCO. Add strike plate. Touch up stucco where steel work burned or over-sprayed.
6th floor restroom, west

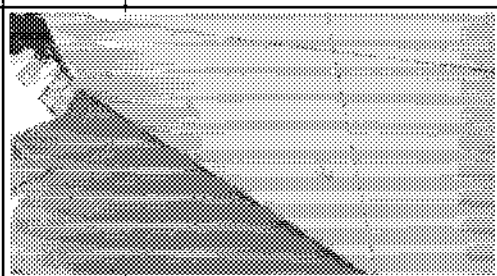
<p>Many low level lights are missing covers. As noted previously, these lights come with security set screws, which were not tightened properly on many of these lights, leaving the covers loose. Replace all missing covers.</p>

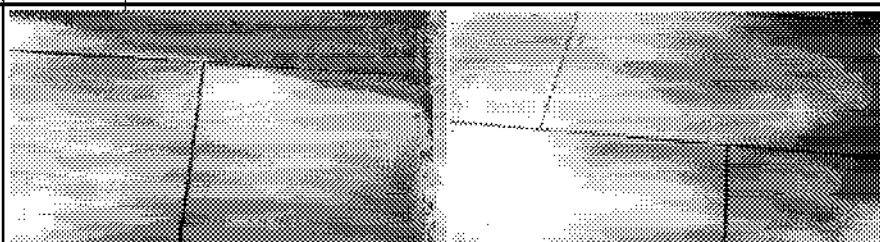
Podium

<p>Pavers near the community room have sealant/adhesive clumps firmly stuck on the face - clean. All pavers should be thoroughly cleaned at conclusion of other punch work that threatens to soil them.</p>

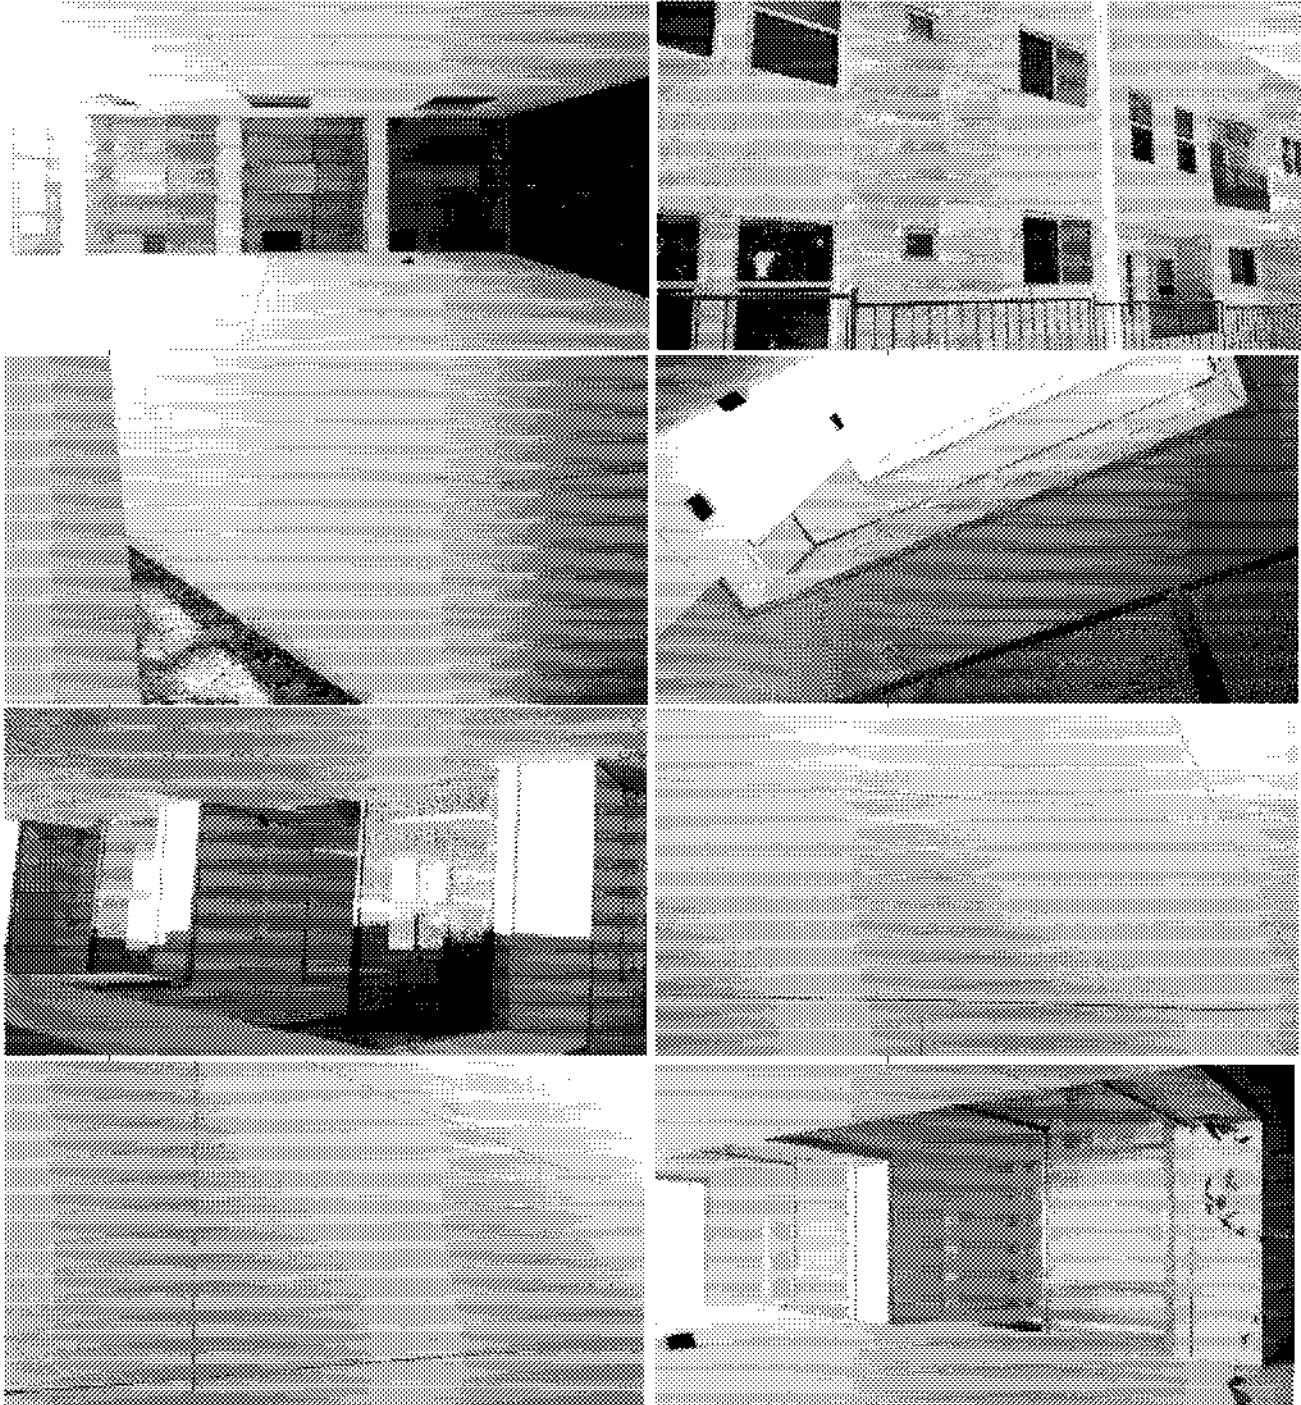
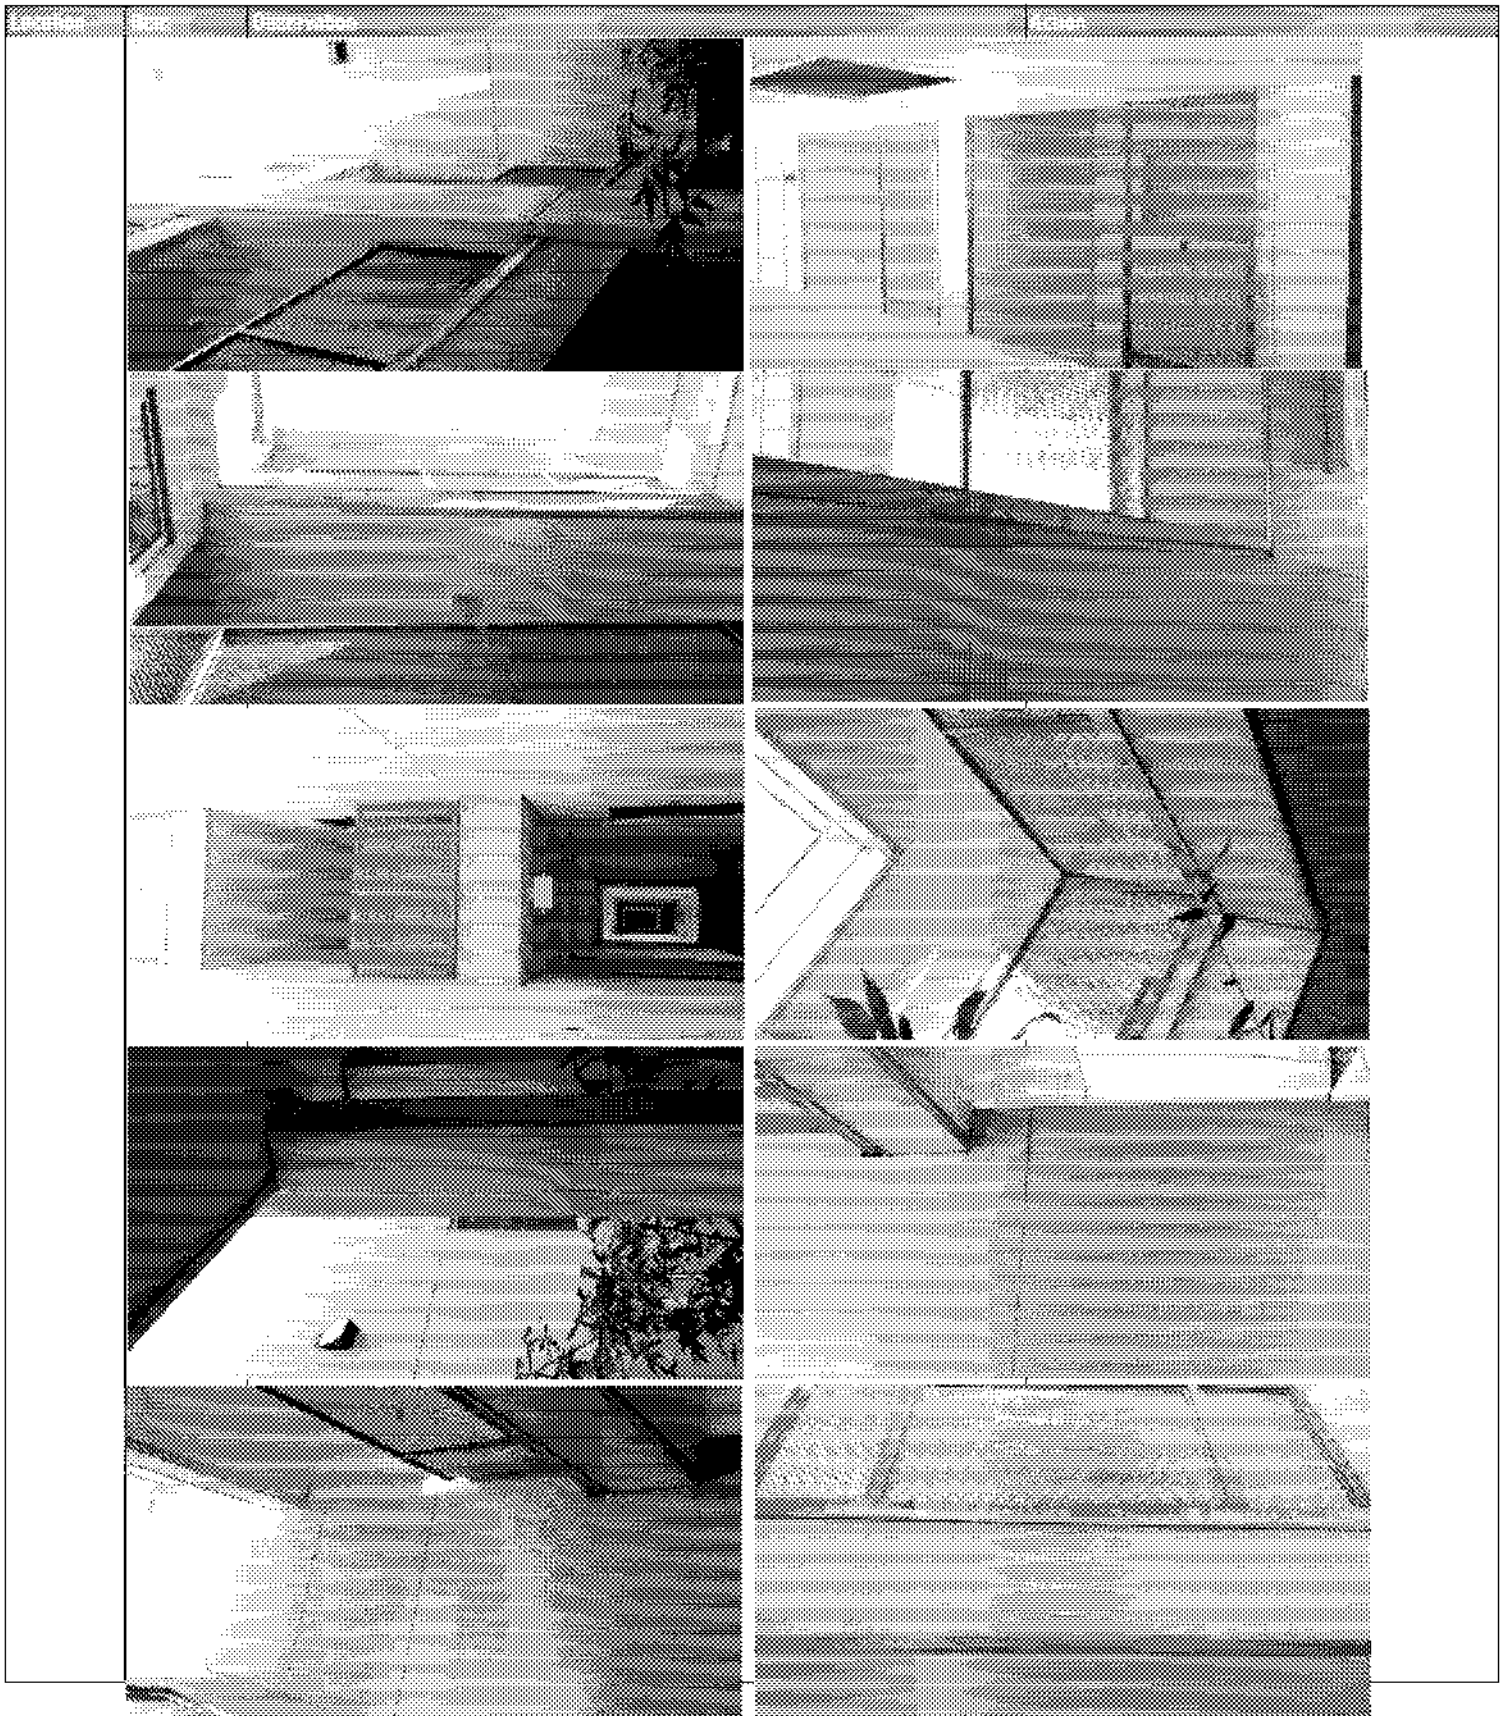
Location	Date	Description	Photos
Stucco		<p>Stucco quality is poor. It is uneven, warped, and scarred on virtually every surface, far below the quality of the mockup. Stucco is also stained in many locations. At time of photography, pressure washing was in progress. Washed areas displayed mixed results: some rust/runoff stains were removed, some were not. No concrete splatter stains appeared to be affected by the wash. The aluminum edge profiles have not improved. They are badly stained and unacceptable as is. Paint is a short-term solution that will significantly add to the Owner's maintenance burden.</p>

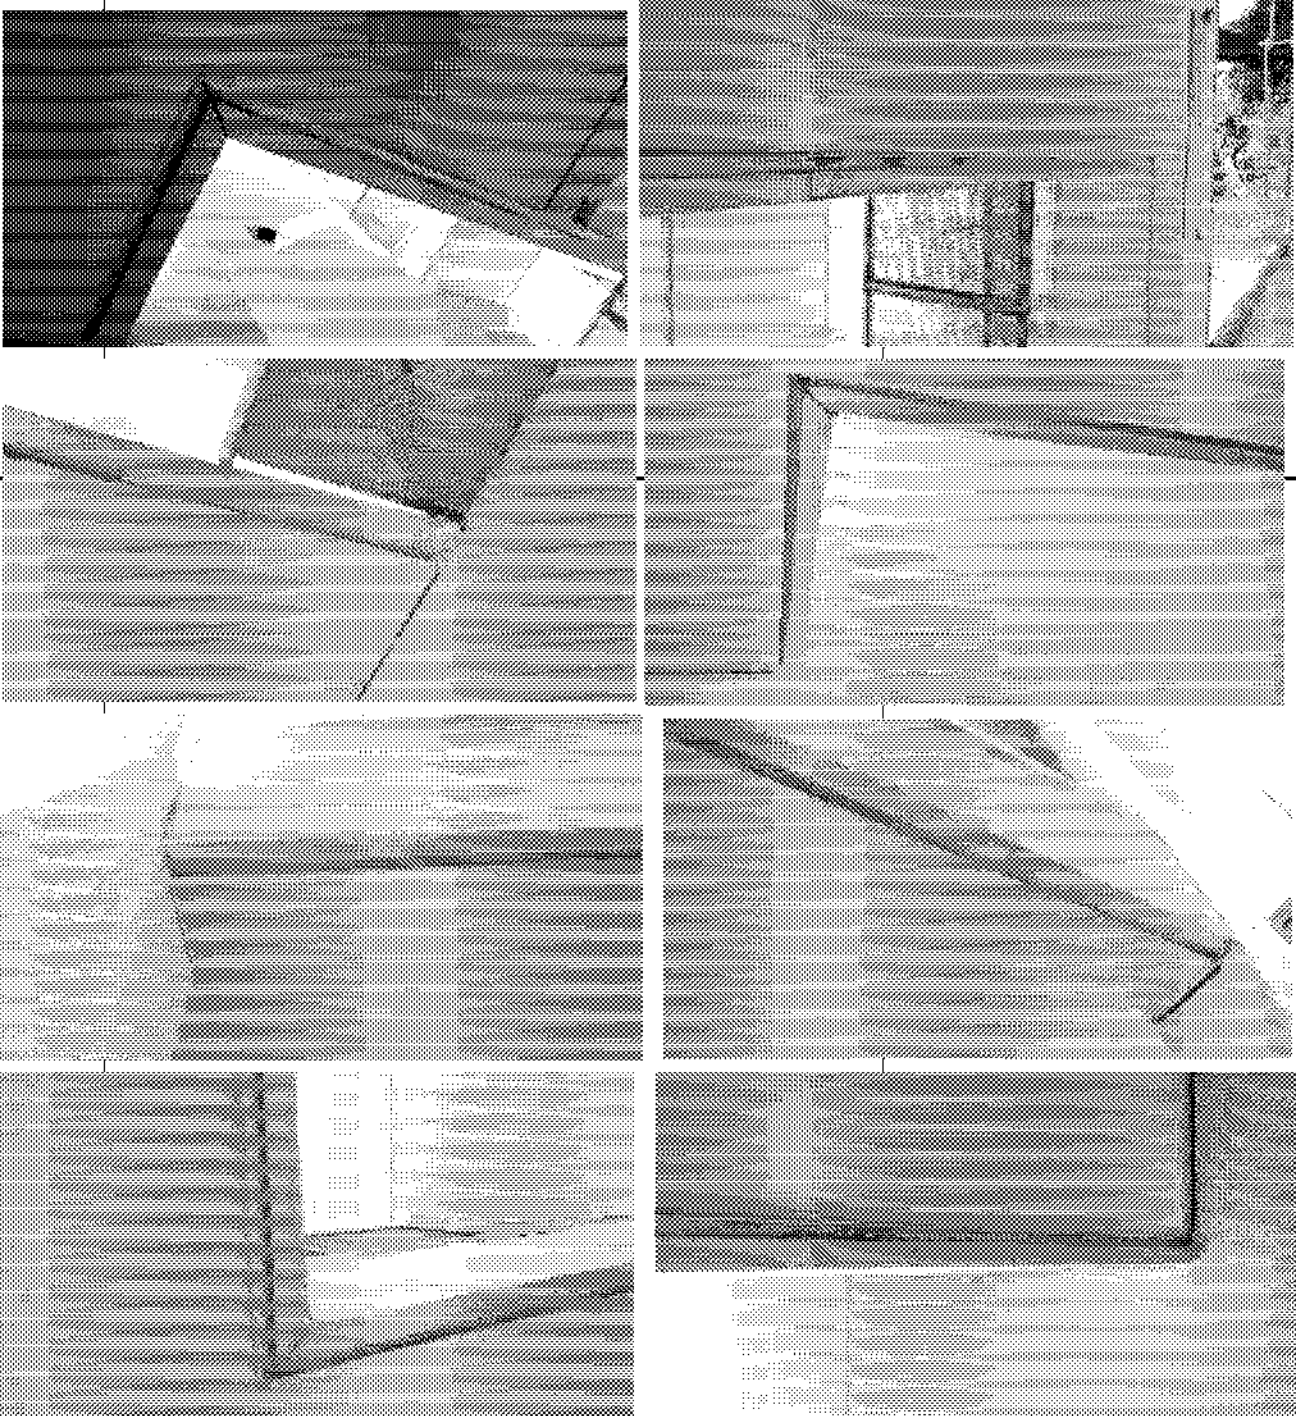
Location	Date	Description	Photos
Soffit Trim		<ul style="list-style-type: none">- Joint gaps are often excessively large.- Frequently stained by mud, paint, sealant, stucco- Some dented or nicked sections- Bad sealant joint between extrusion and hardiesoffit

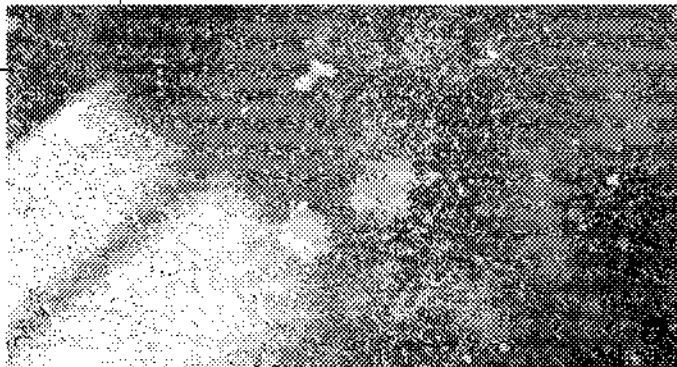
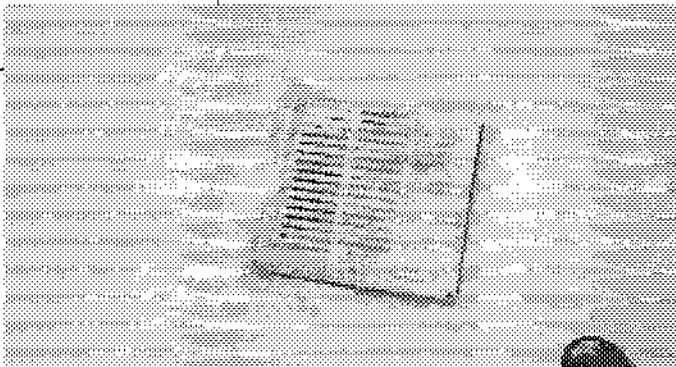
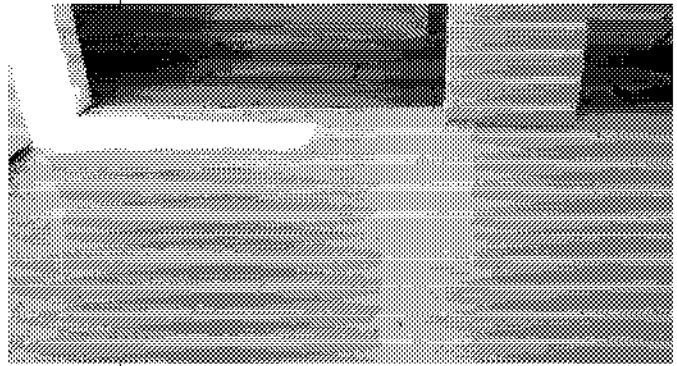
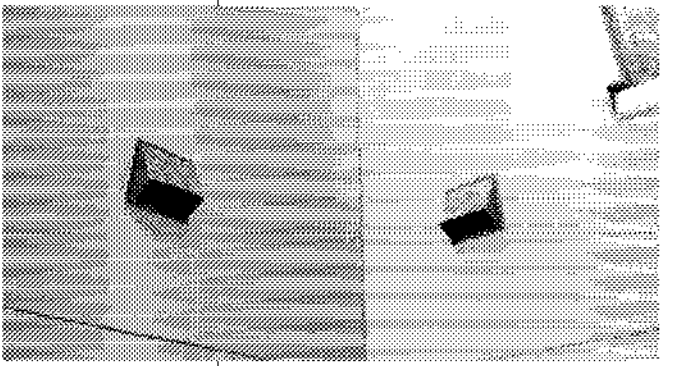
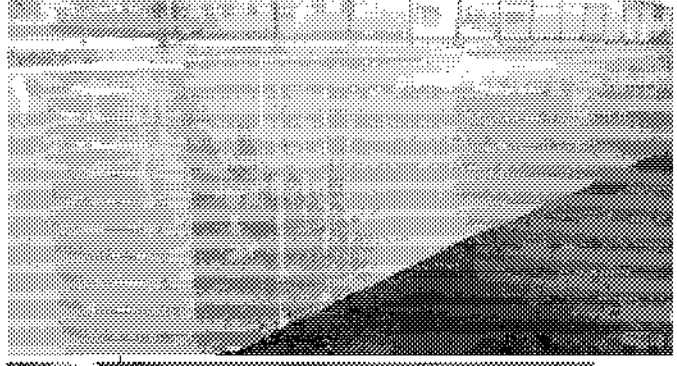
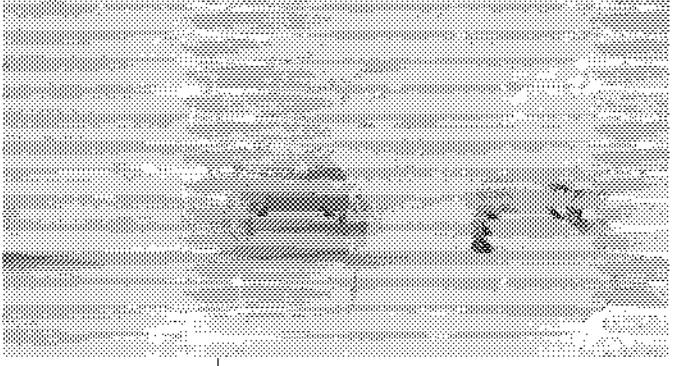
Location	Date	Description	Photos
Misc. Cleaning & Repair		<ul style="list-style-type: none">- Gravel beds were not well cleaned after construction - mortar/stucco drops and other trash still present- Deck drains shall be completely free of concrete and other obstruction.- Vent covers shall be cleaned to like-new condition.- Remove staining from vertical concrete, including below catwalk, and along internal site drive

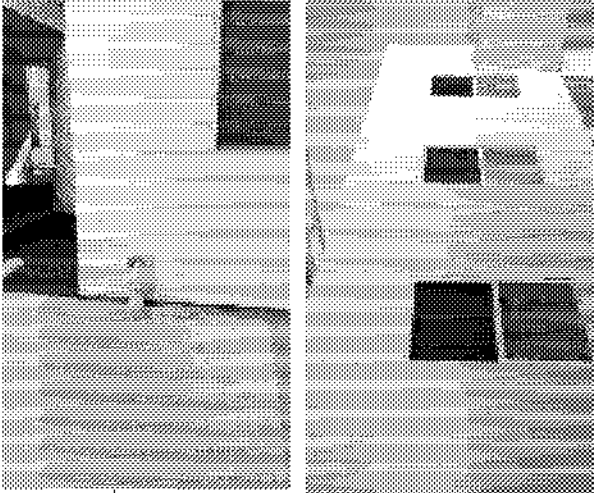
Bldg 3

Install missing downspout & overflow.
Door Paint, all

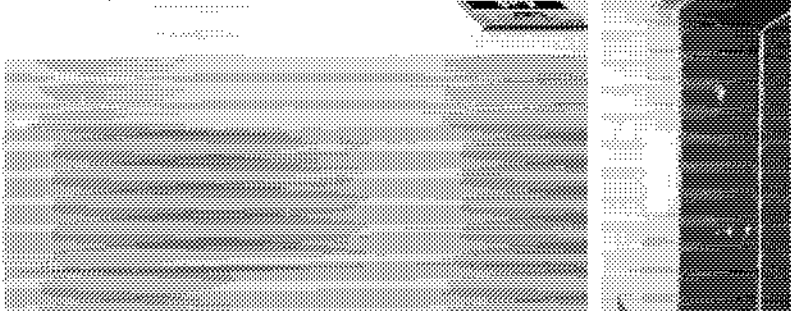
Re-check & touch up door & frame paint - several weak spots noted.
Breezeway lights

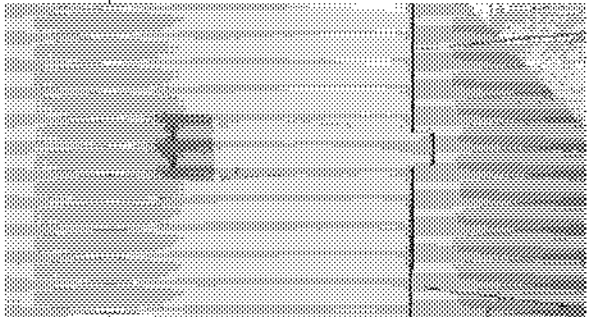
Typical Breezeway light repairs: - Remove debris from lenses - Confirm all tamper-resistant screws are installed - Replace cracked or warped lenses - Tighten loose fixtures to soffit
Elevator 4 elec room

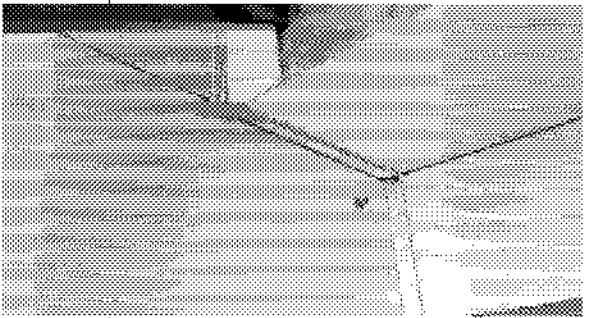
Remove exposed conduit & run concealed. Repair stucco.

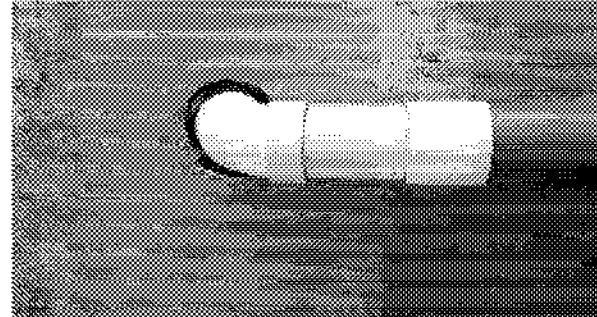
<p>Pipe penetration must be firestopped and sealed in accordance with an approved 3hr UL system. Currently, foam padding is exposed, partially filling the opening. Paint pipe balcony gray.</p>

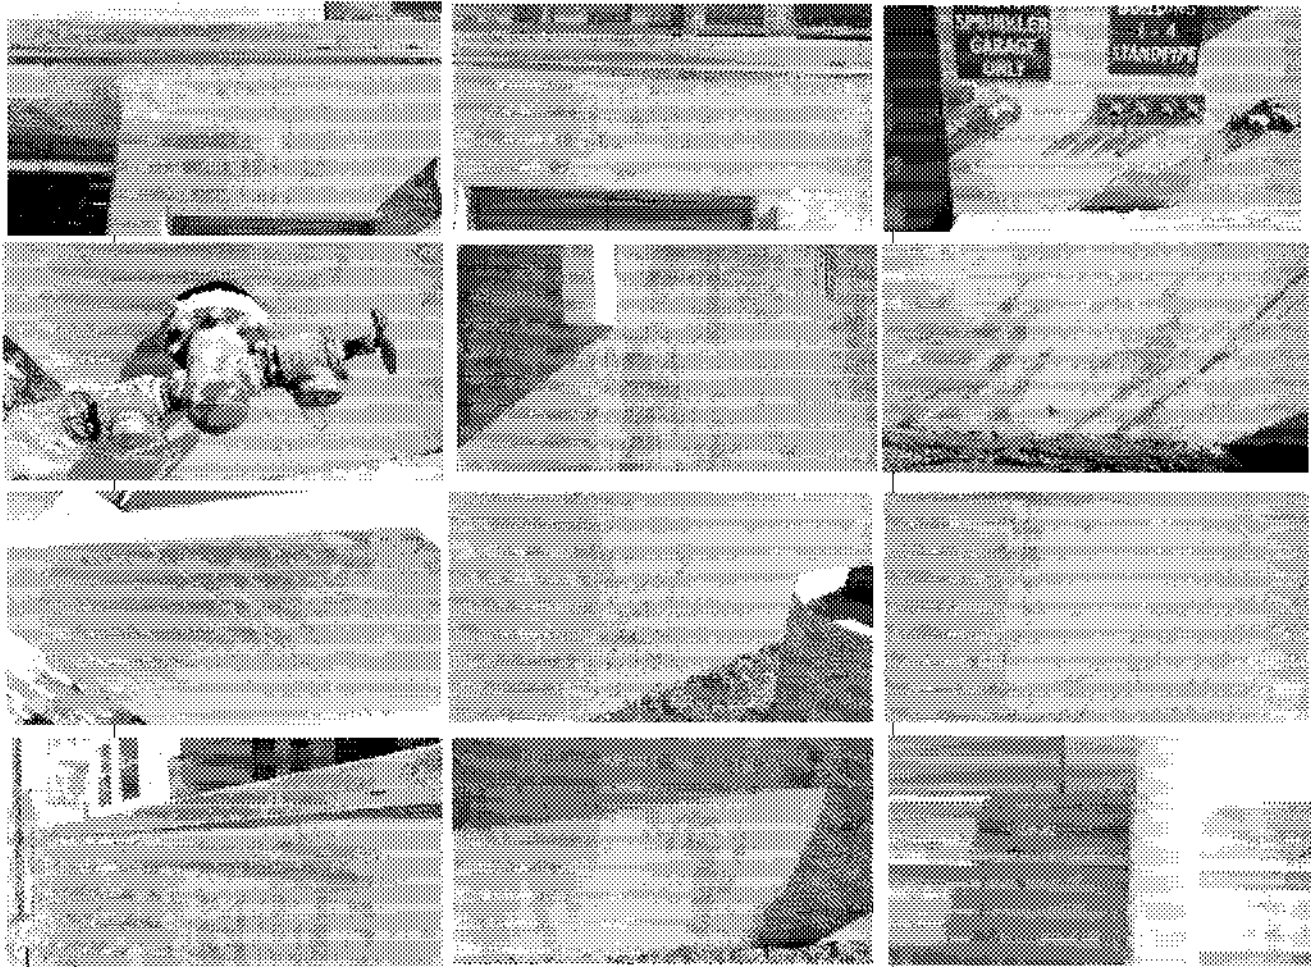
Garage West Concrete Exterior	<p data-bbox="191 174 1419 205">Remove concrete splatter from entire wall & FDC connection. Parge scarred/textured areas. Remove staining & markings.</p>

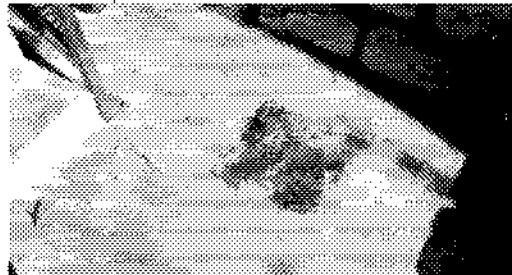
South Stair 1, bottom	<p data-bbox="711 1205 1198 1236">Clean and paint extra embed plate, balcony gray.</p>

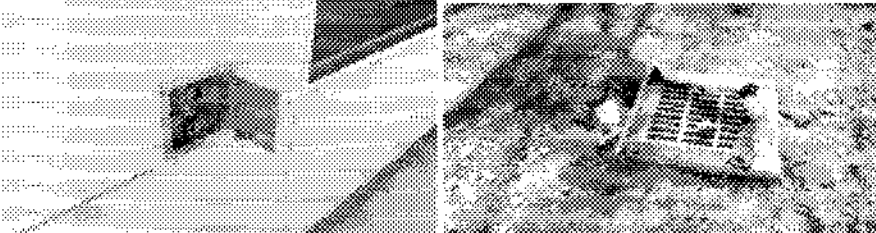
SE Bldg 1	<p data-bbox="191 1499 1484 1530">Hose box will not close, due to hose connection placement. Remove filter fabric, clean, add soil to fill sinkhole adjacent to drain.</p>

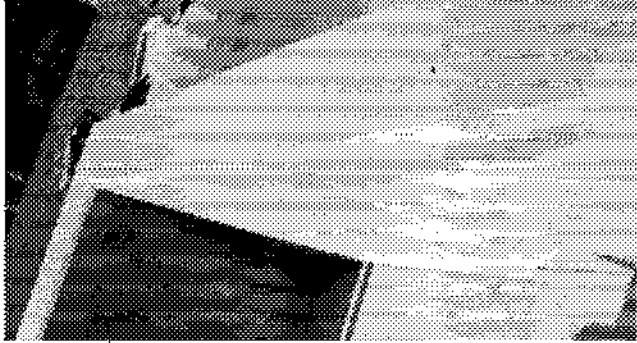
West Podium Stair

<p data-bbox="196 1199 548 1230">Float chipped areas smooth, clean.</p>

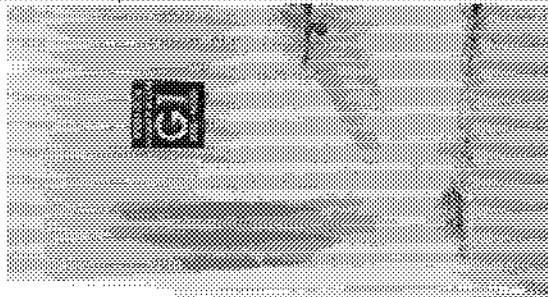
Location	Photo	Observation	Action
G1 North

This wet spot was 1st noticed 1-2 months ago and doesn't seem to have changed. Can't tell if this is a stain or waterproofing failure. This location is adjacent to the long-open pit where the garage was extended for FDC access on the podium level.	
All Garage

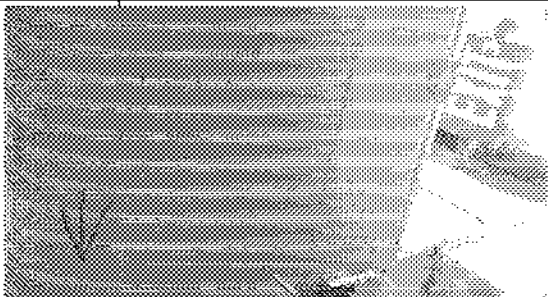
All ceilings, walls, floors require cleaning to eliminate layout marks, weld burn marks, stains, etc.	
Striping

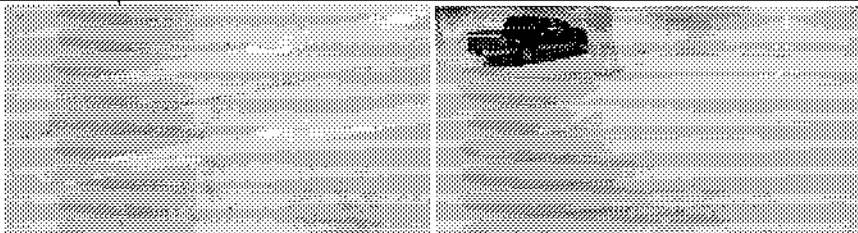
Striping flaws noted - unsure if this is wear/tear or application error. Also, incorrect directional arrow on G1 has not been addressed.	
Electrical
